# **CASTING BASIN GATE MAINTENTANCE RECORDS**

CYCLE 6

# Kiewit-General Inspection Report

**PROJECT:** SR 520 PONTOONS

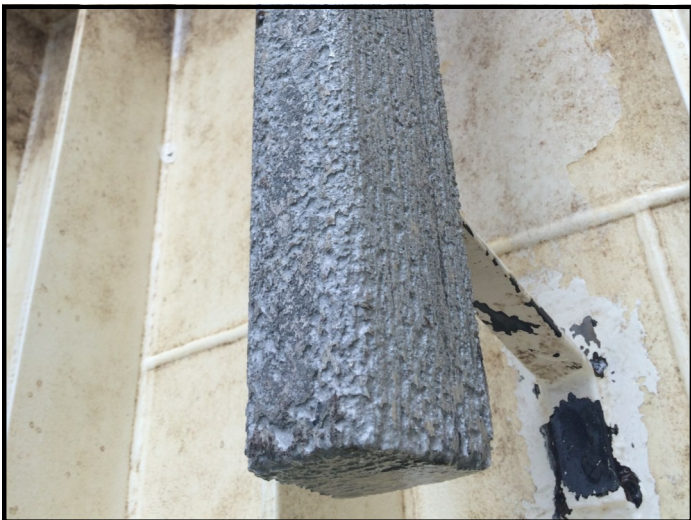
2) Aluminum anodes showing expected wear. Reference attached Norton inspection memo.

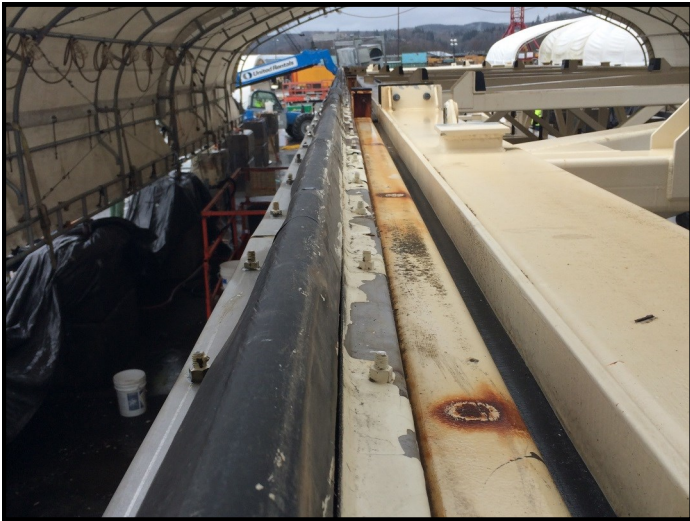
6) T2 zinc anode 60% remaining.

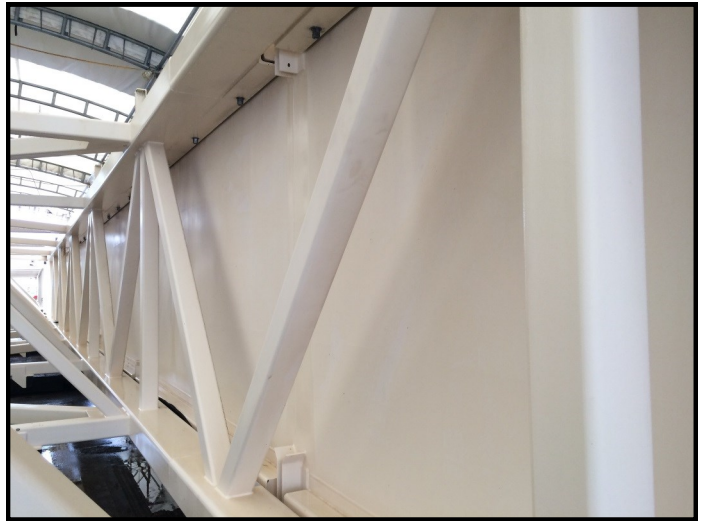
7) Duraplate235 on stainless clips did not adhere. To be removed, blasted, primed, and epoxied.

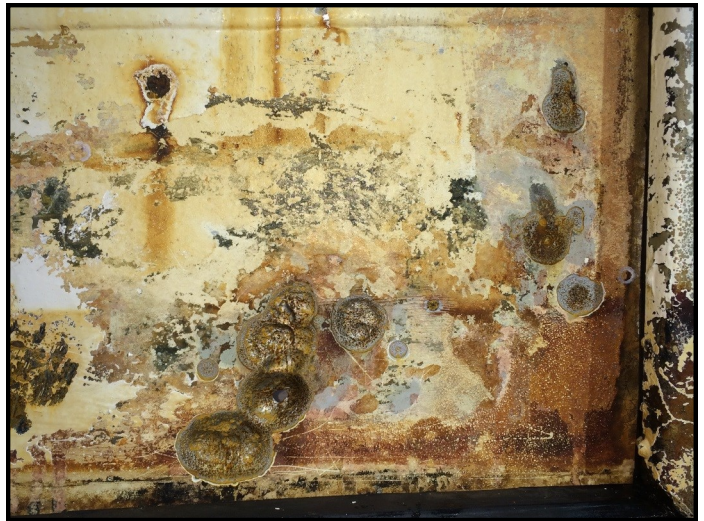
9) Large original Duraplate235 coating failure area down to primer from pressure washing.

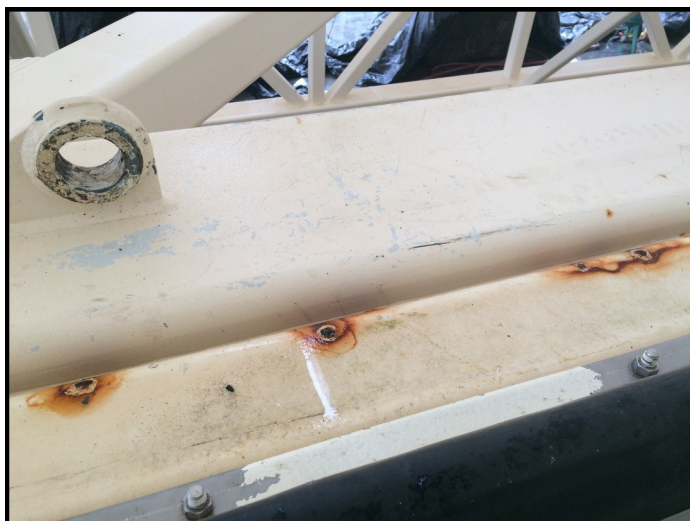
10) T1 excessive corrosion at bottom to vertical intersection at 1T.

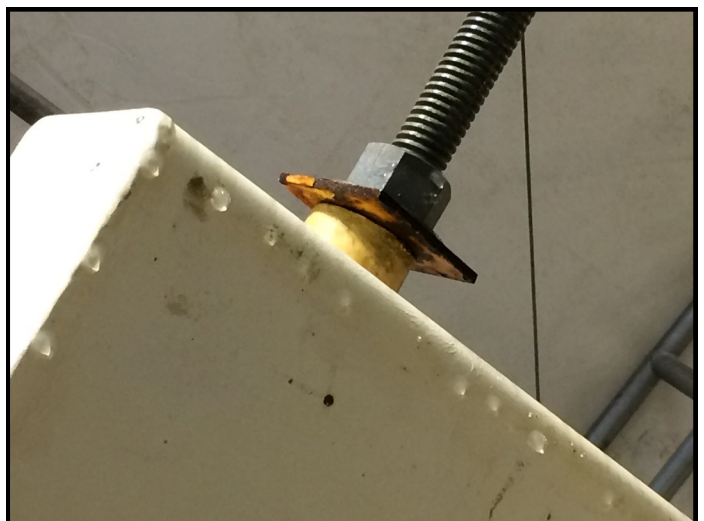
11) Rust spots on top of T2 and Duraplate failure to primer.

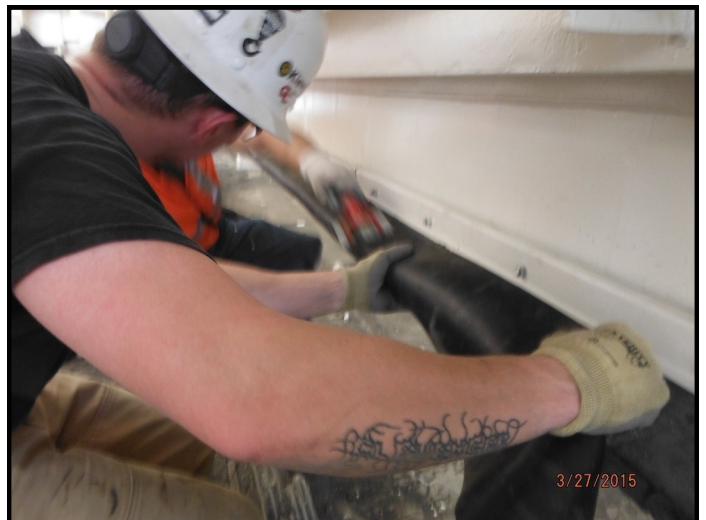
51) Seal replaced after 4 days min of cure.

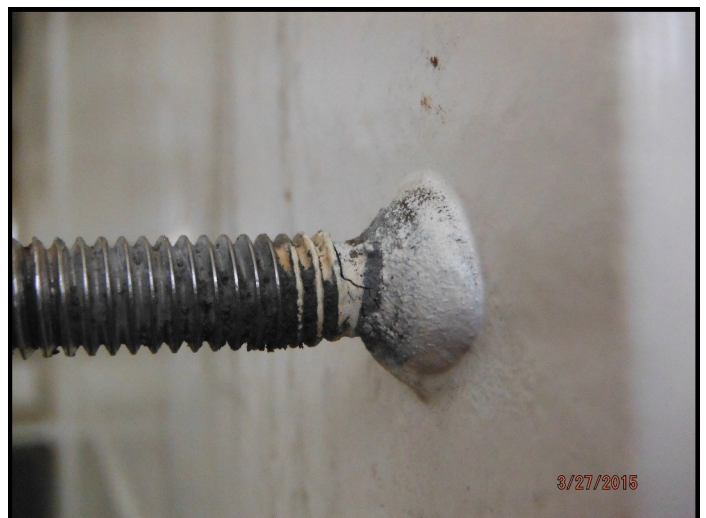
53) A stud sheared on GL1 T1 vertical seal during seal install.

55) Both studs were removed and replaced with a new 316L SS stud.

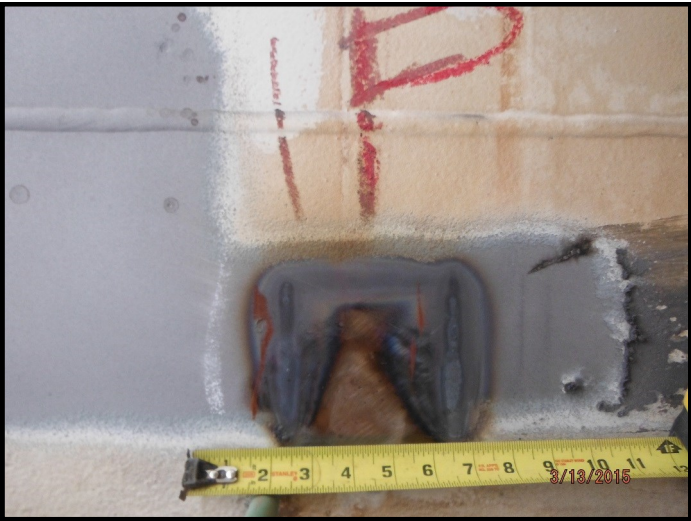
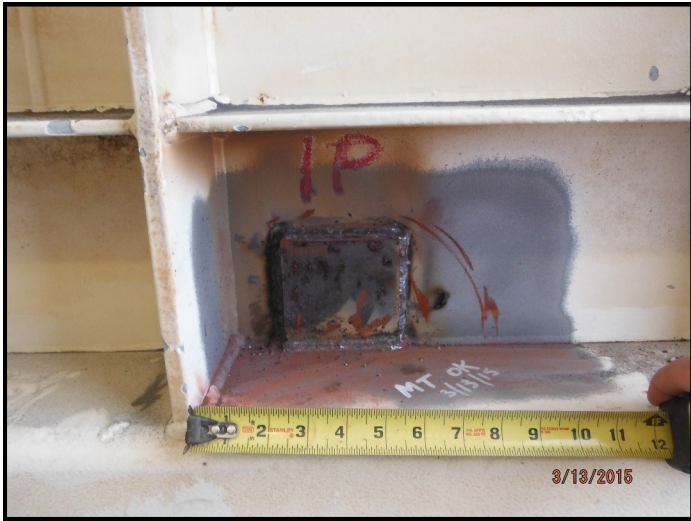
1 P

9T: 1/4" diameter x 1/8" pits existing repair

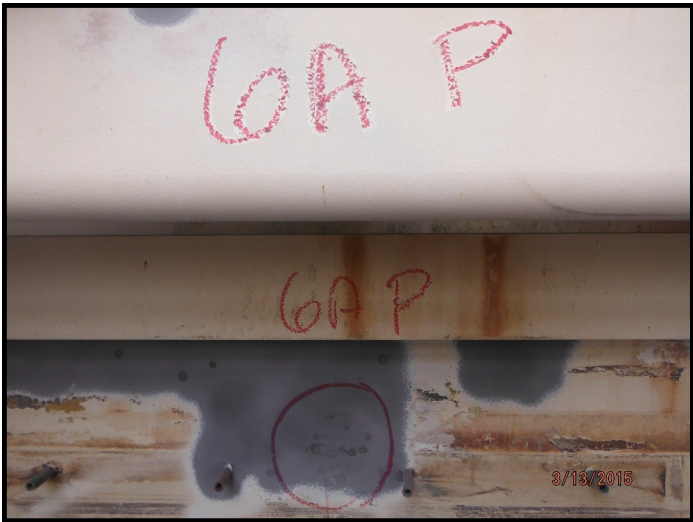
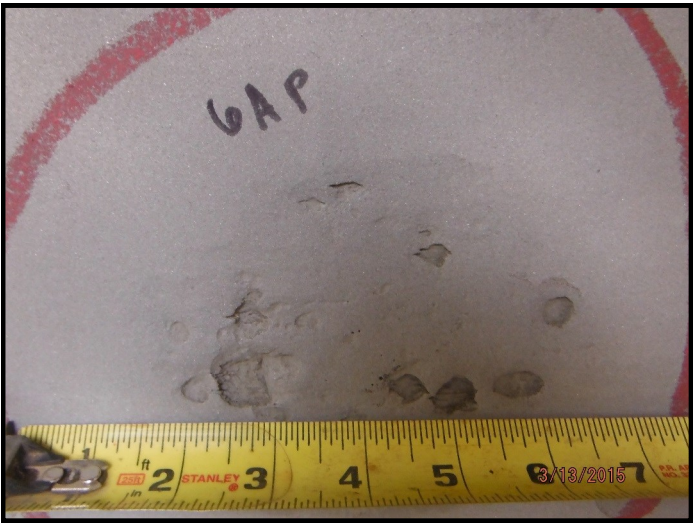
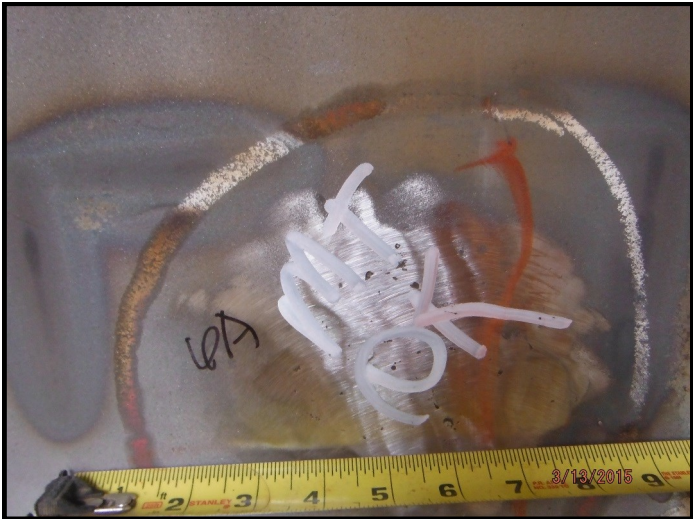
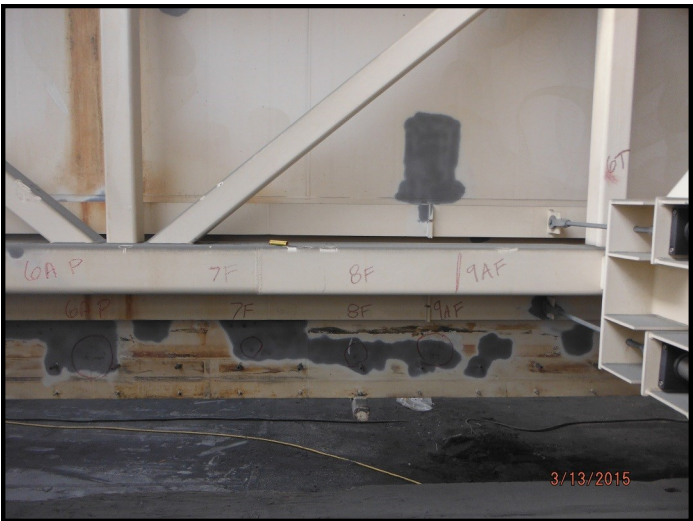
6A P

22" before Grid 7T: 7EA 1/4" diameter x 1/8" pits existing repair

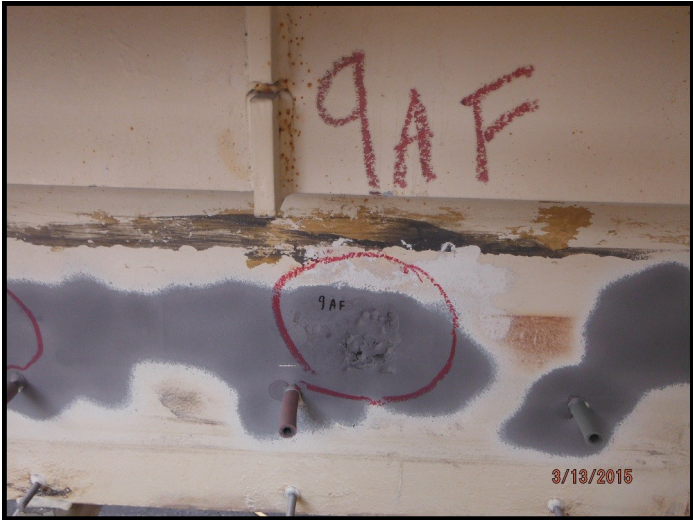
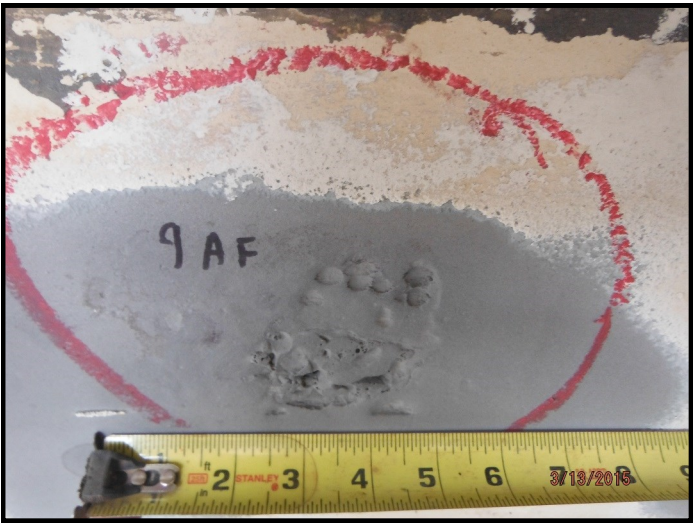
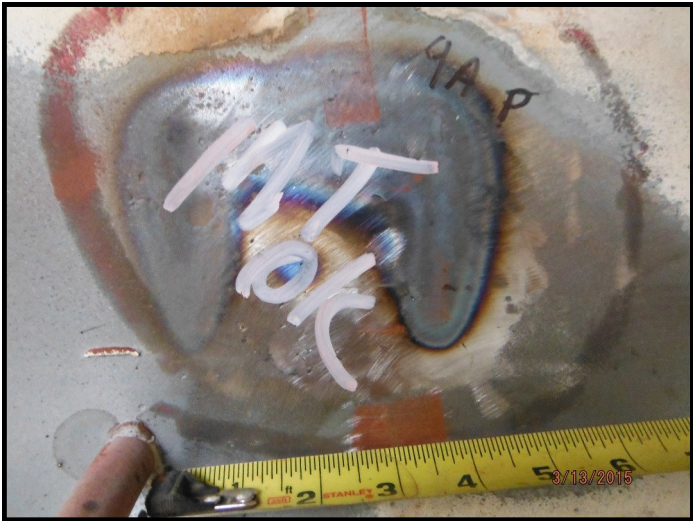
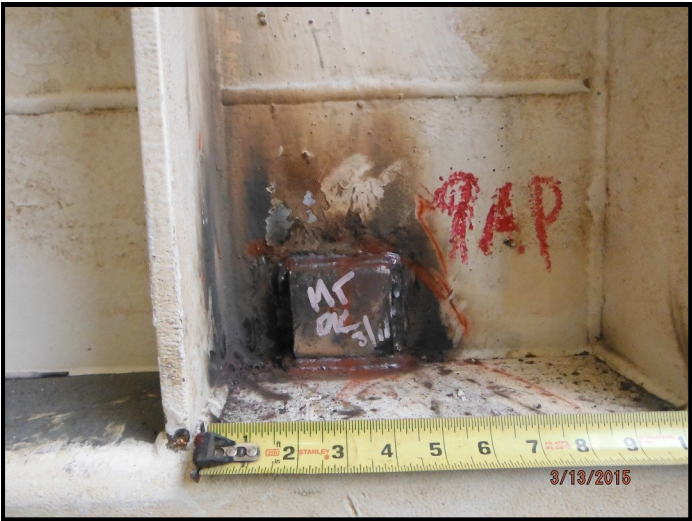
9A F  
28" after Grid 6T: 8EA 1/4" x 1/16" pits existing repair

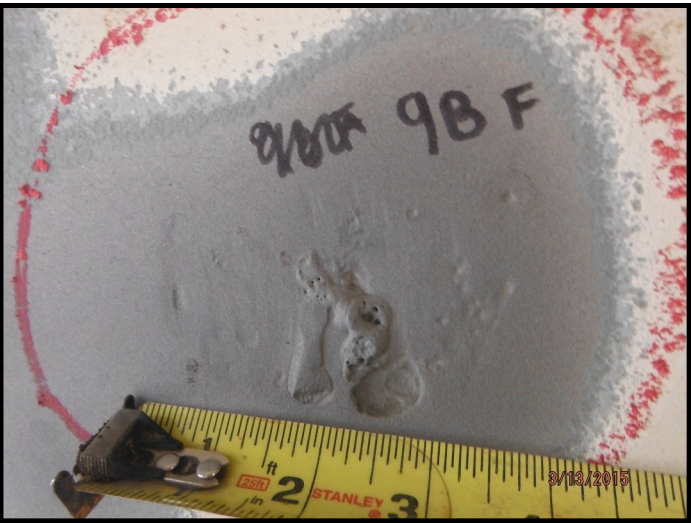
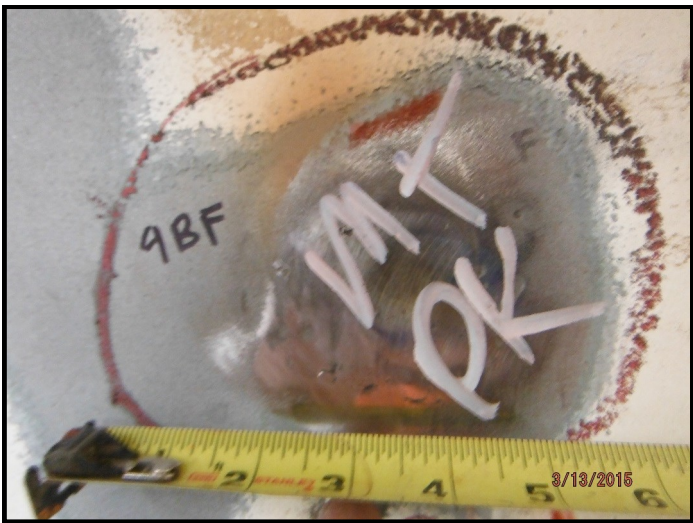
9B F

17" before Grid 6T: 1/2" diameter X 1/8" pit existing repair

NO PLATE REQUIRED

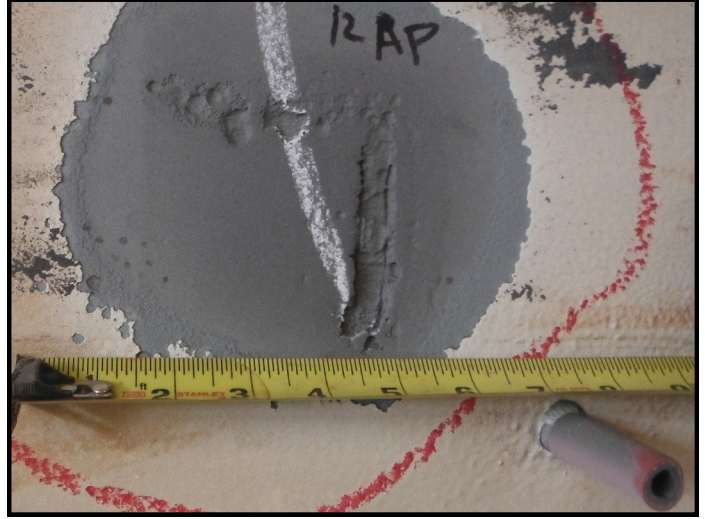
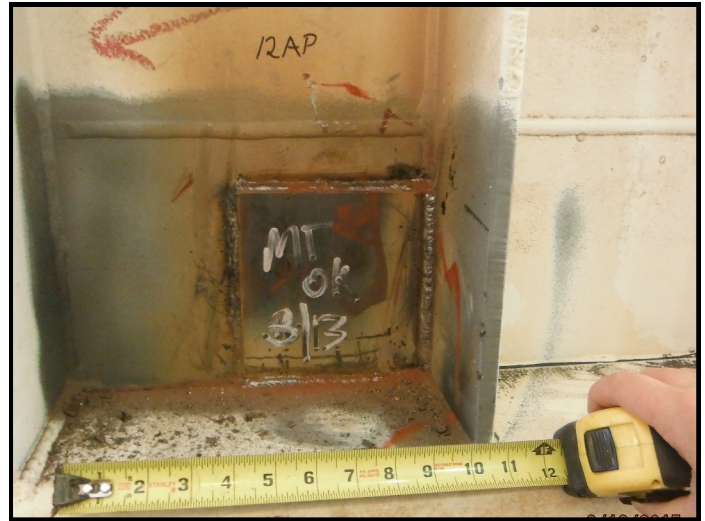
# 12A P

63" before Grid 6T: 1/2" diameter X 1/8" pit

Remove existing plate and add larger plate to extend 1" past repair

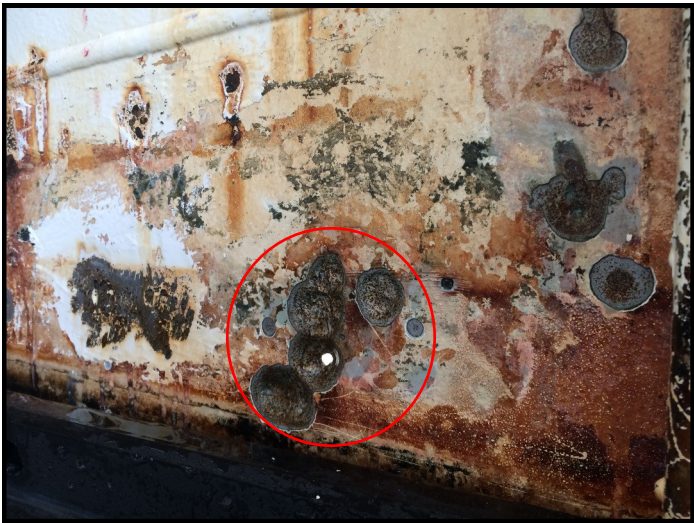
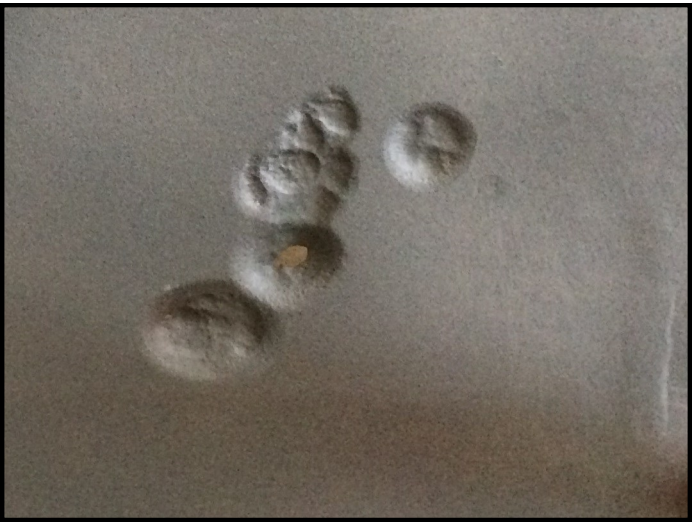
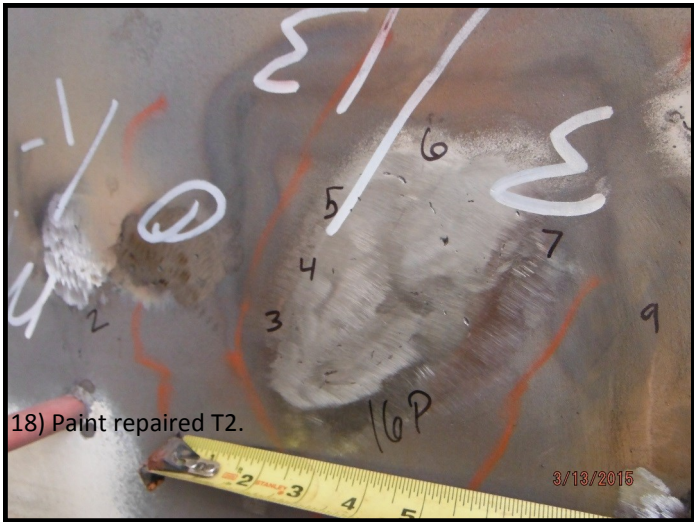
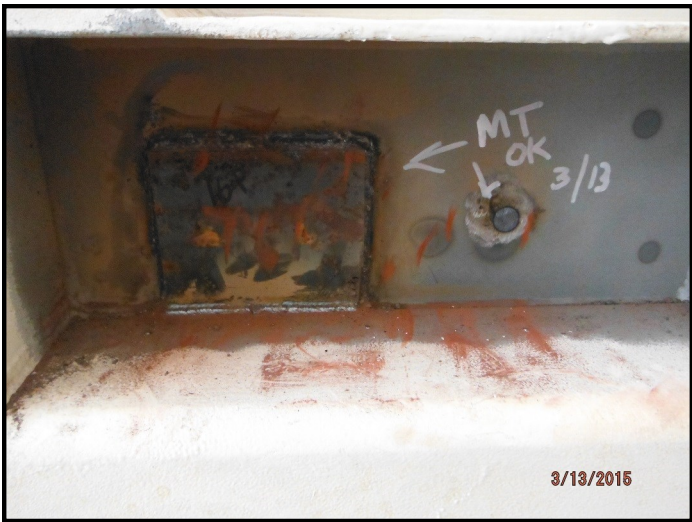
16 P

12" after Grid 1T: 1/4" hole, 4EA 3/4" diameter x 3/16" pits

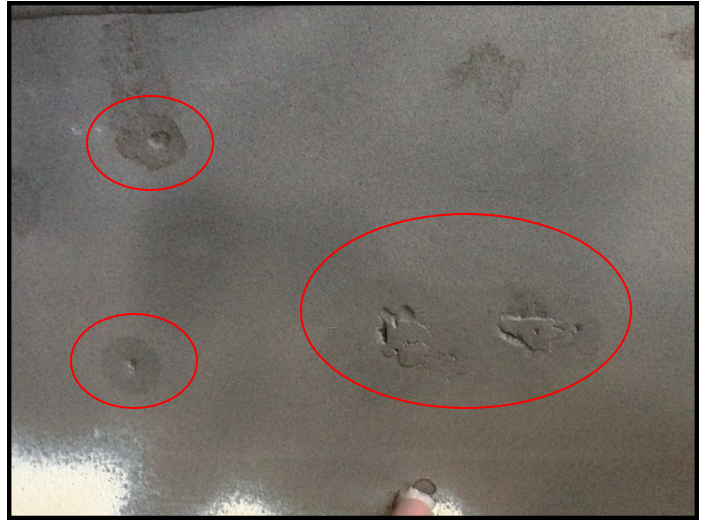
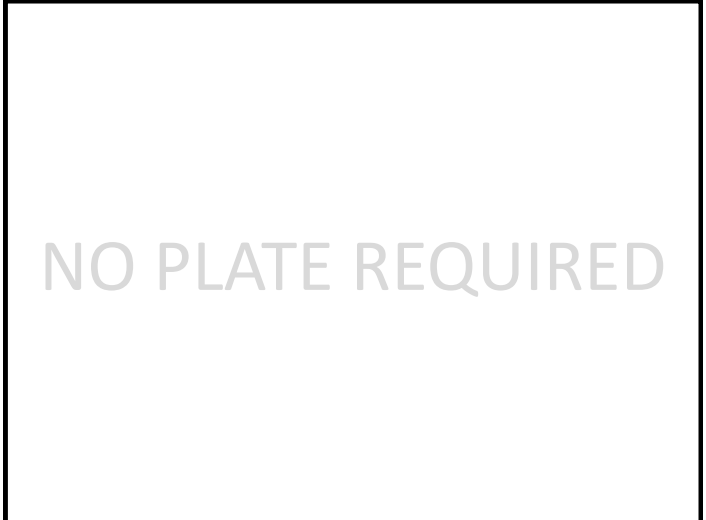
17 F

18" after Grid 1T: 2EA 1/8" diameter X 1/16" pits, 2EA existing repairs with 1/16" pits

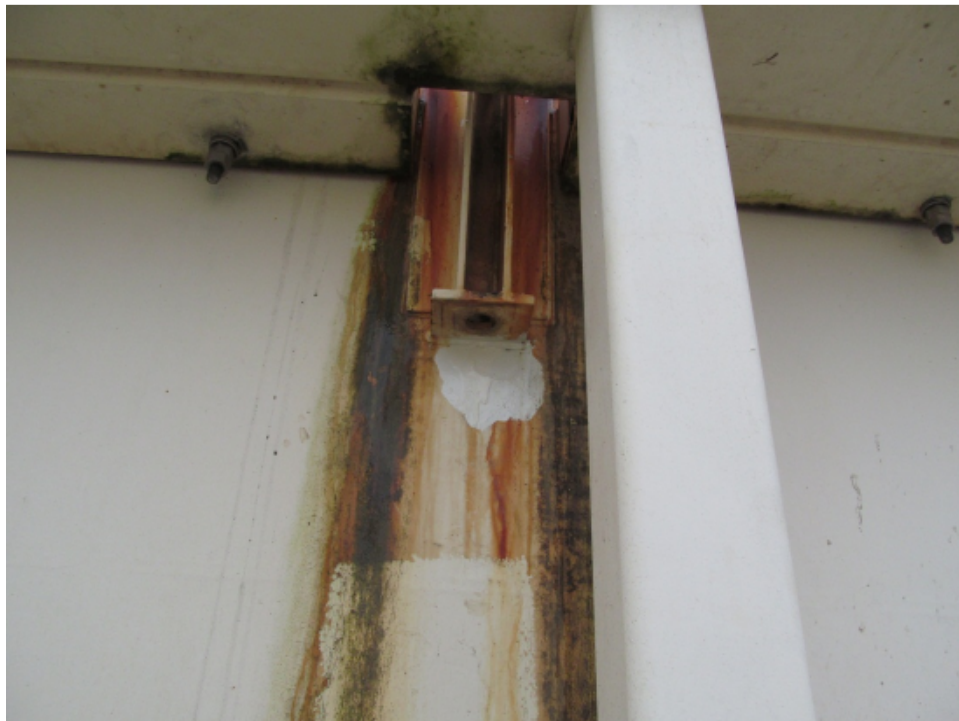
**Photo 3: Gouge in Barrier Wall Stiffener**

9. Barrier wall stiffeners showed local gouges at the stiffener edge. These gouges are typically 1/16" to 3/16" deep, and 1/2" to 1" tall, see **Photo 3**. The gouges may be from overgrinding during paint repair, however did not appear to be significantly worse than cycle 4 and 5.

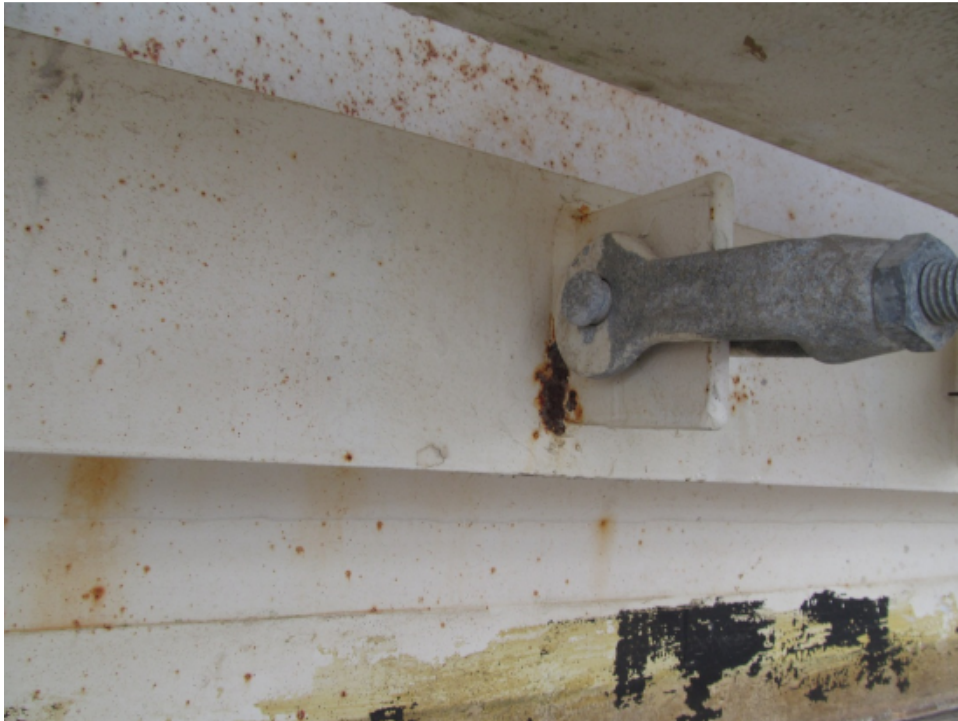
**Photo 7: Rusting at Seal Stop End Plates**

1. Damaged paint on upper truss-to-truss bearing plates.
2. Minor surface rusting at bottom seal stop plates, see **Photo 7**.
3. Minor surface rusting at continuous WT sections connecting spring assemblies to barrier wall.
4. Slightly bent threaded rod at the spring assembly at Grid 5.
5. Galled paint on the front sill bearing plates around the UHMW fasteners.
6. Grinding from previous paint repair has caused local pits at the back of the barrier wall. This may be from different coating thicknesses or some minimal loss of section. This does not appear to be worse than in Cycle 4 or 5.
7. The gate stop bearing plates showed signs of surface rusting
8. The Belleville spring tie rod plate connections at the gate barrier wall contained surface rust see **Photo 8**.
9. The grid A truss chord HSS had minor surface rust on the underside of the member at grid 5.5T.

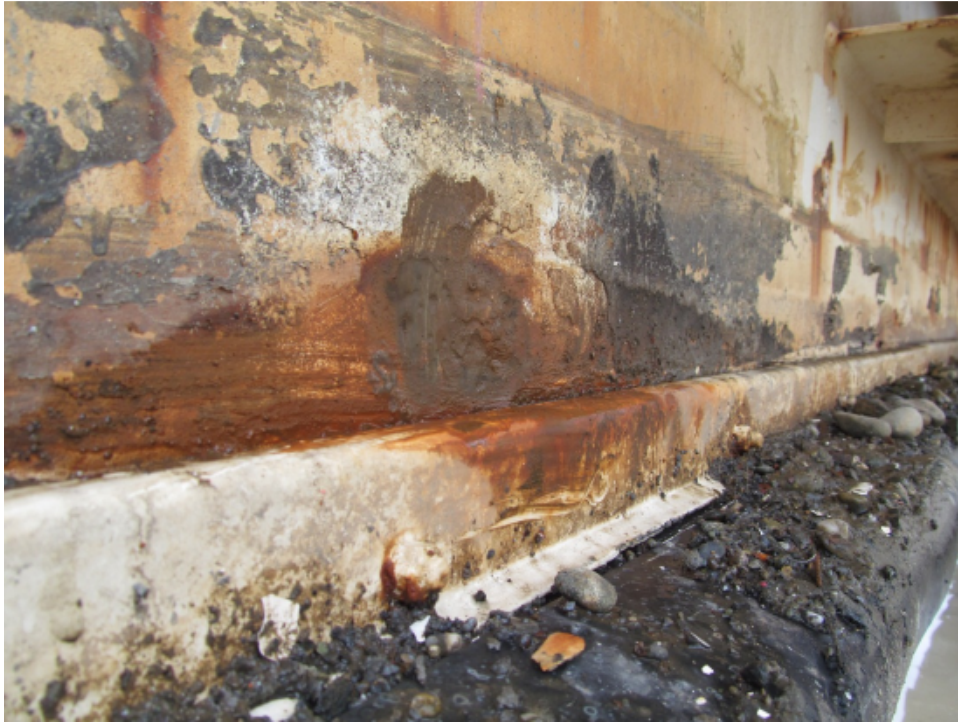
**Photo 10: Gouge in Vertical HSS**

11. The vertical seal support HSS had a small divot at 1T. This should be repaired per the previous weld repair procedure, see **Photo 10**.
12. Several areas of increased corrosion were found in the lower section of the gate barrier wall. Several areas were in locations of previous repairs, and several other locations were found after pressure washing of the barrier wall. The back of the barrier wall had not been completely pressure washed previously, so it is likely that these areas existed previously. The locations and repairs are below. See the RFI log for the complete repairs and reference sketches.

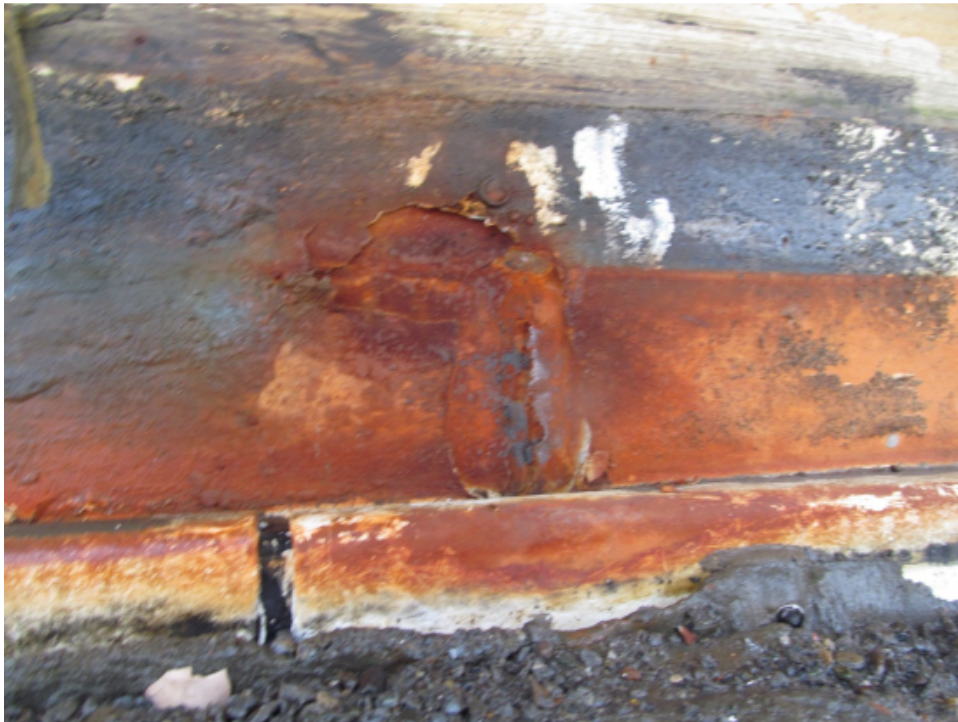
**Photo 11: Area of Increased Corrosion at Previous Repair at 9T**

- a. 9T Lower Barrier Wall - Grind out bad weld metal from previous repair and fill with weld metal per previous repair procedures, see **Photo 11**.

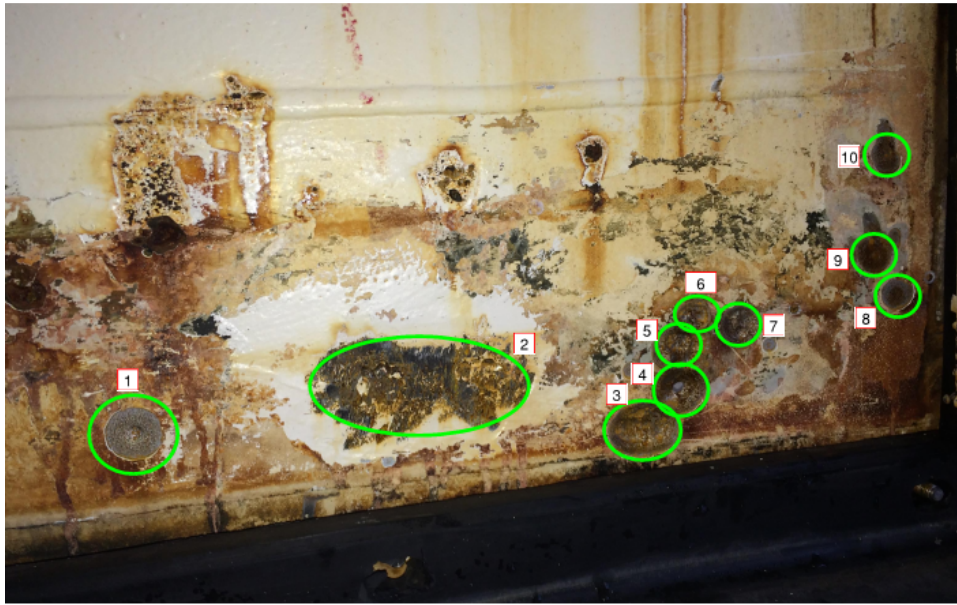
**Photo 12: 1" Previous Weld Repair at 4T with weld Burn Through**

- k. 6T Lower Barrier Wall: 1/2" diameter gouge - Grind out bad metal and fill per previous repair procedure.
  - l. 4T Lower Barrier Wall – The weld from the cover plate burnt through the barrier wall and is a source of additional corrosion. Repair per sketches provided, see **Photo 12**.

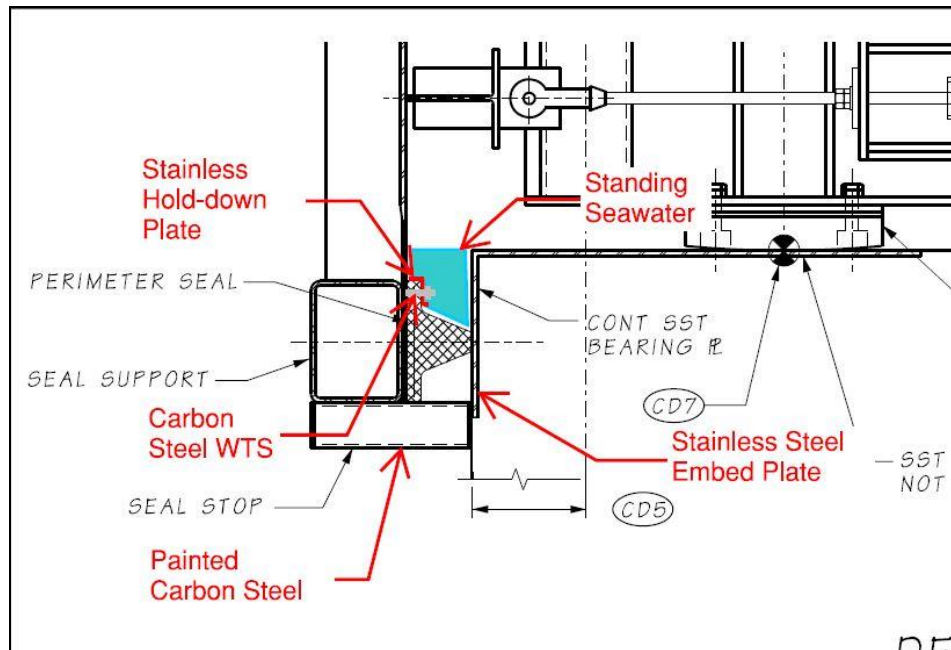
Image 1: Water filled sump between the gate and the concrete. A stainless steel clip is used to secure the seal to the carbon steel gate. Coating failure, combined with dissimilar metals, resulted in aggressive corrosion in a relatively short period of time.

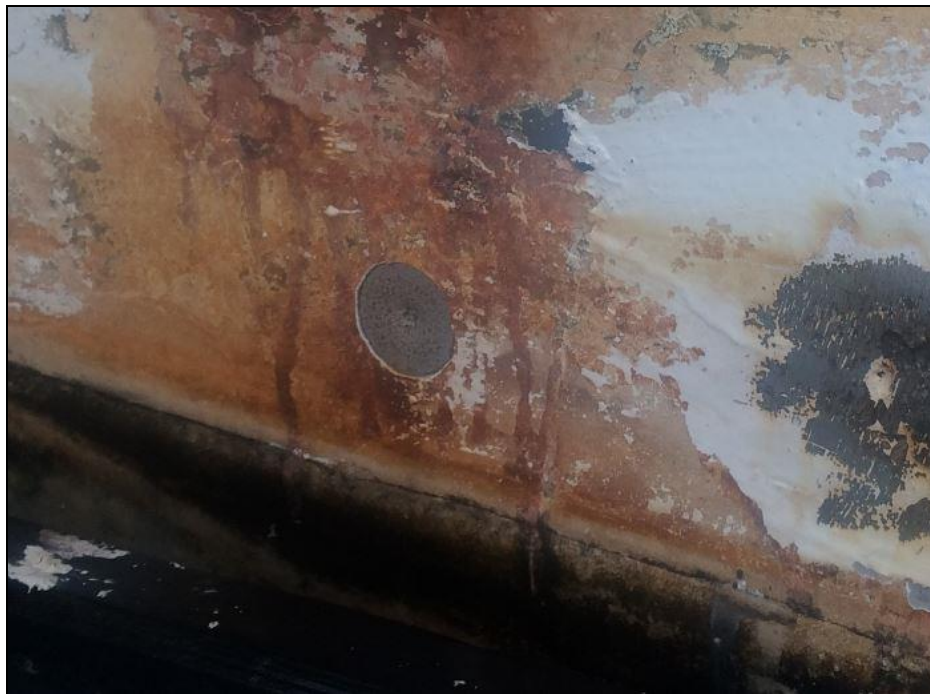
Image 2: Most of the corrosion occurred adjacent to the stainless steel clip.

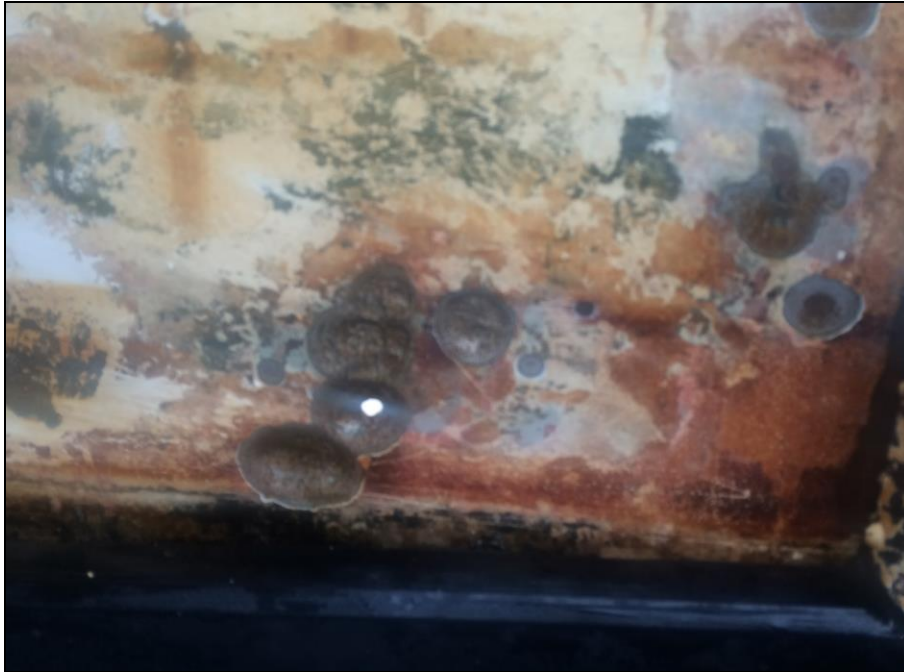
Image 3: Corrosion on the bottom right corner of the gate. At this location there is another stainless steel clip running vertically. There is more stainless steel at this location, which explains why the penetration occurred here.

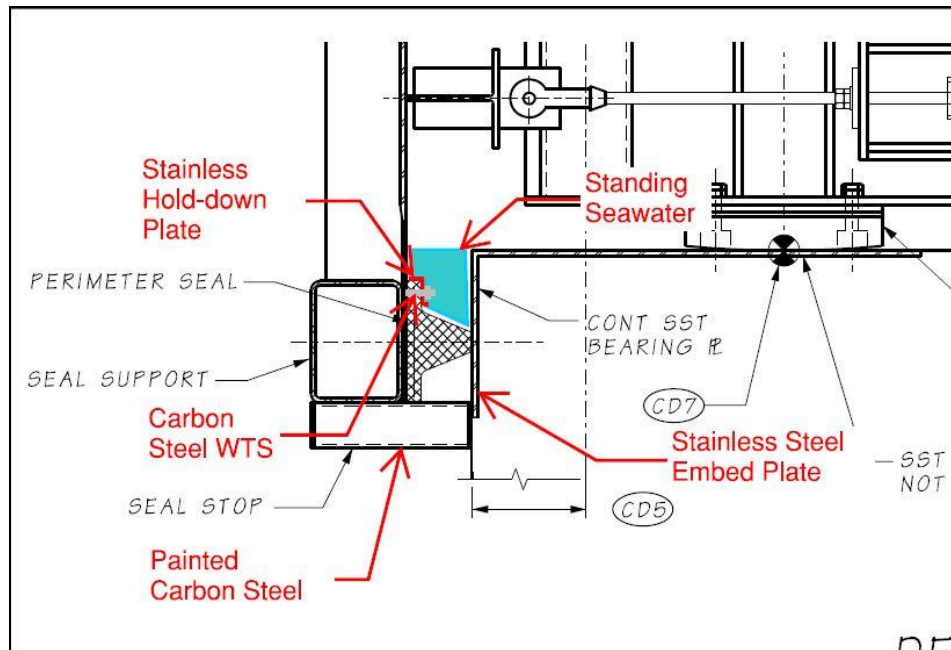
Image 1: Water filled sump between the gate and the concrete. A stainless steel clip is used to secure the seal to the carbon steel gate. Coating failure, combined with dissimilar metals, resulted in aggressive corrosion in a relatively short period of time.

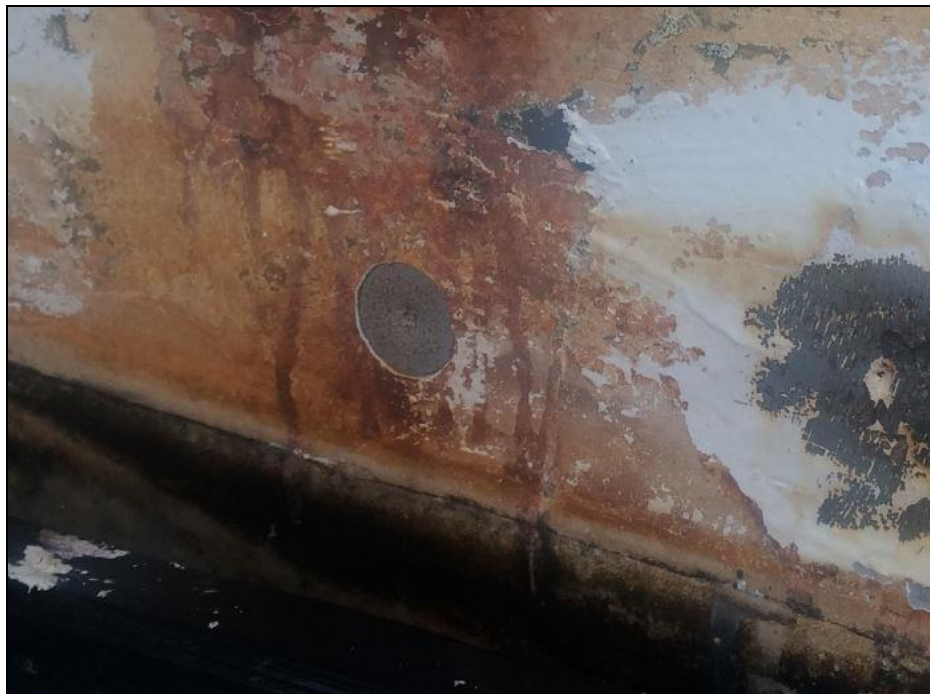
Image 2: Most of the corrosion occurred adjacent to the stainless steel clip.

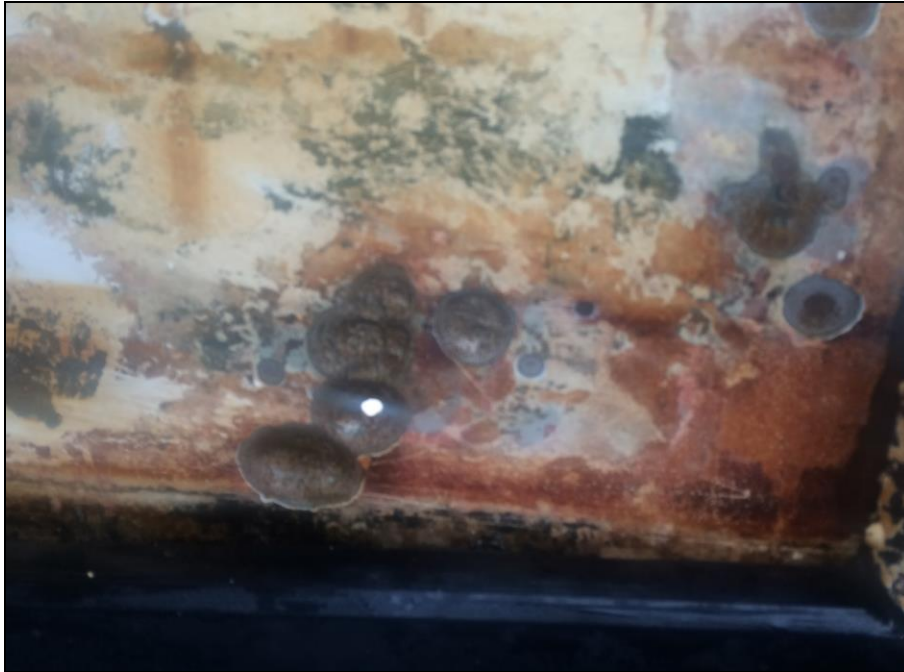
Image 3: Corrosion on the bottom right corner of the gate. At this location there is another stainless steel clip running vertically. There is more stainless steel at this location, which explains why the penetration occurred here.
